Attachment to Oct. 2, 1998 1&E of Surface Management notice (se.... no. UTU 66357) -Photographs (enclosed with attachment in a page size plastic enclosure). The reverse of photos and panorama are marked with the serial number, date, and numbering as below. Descriptions are as follows

Attachment to Oct. 2, 1998 I&E of Surface Management notice (serial no. UTU 66354) -- The general location of the photographer and angle of the photo is on the opposite side of this page; the reverse of the photo is marked with the serial number, date, and numbering below).

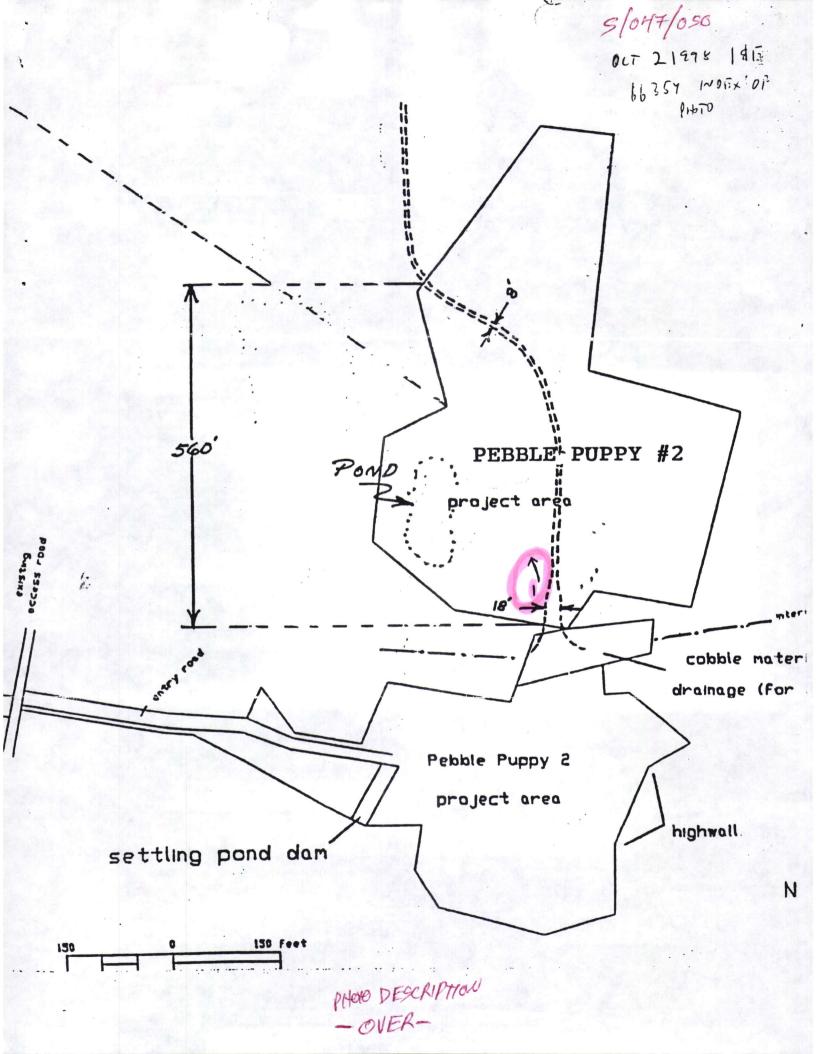
Photo 1 - [wide angle] view to NNW of unreclaimed disturbances in the south-central part of the project area (old placer plant was set up to left of posts (green arrows), oversized stockpiles are at right (red arrows) and old settling pond was at left (black arrow). Compare with left-hand side of panorama 1 from Oct. 20, 1997 inspection.
